CALSPAN ON-SITE AIR BAG DEPLOYMENT INVESTIGATION

CALSPAN CASE NO. 91-14

FLEET - 1992 PLYMOUTH ACCLAIM

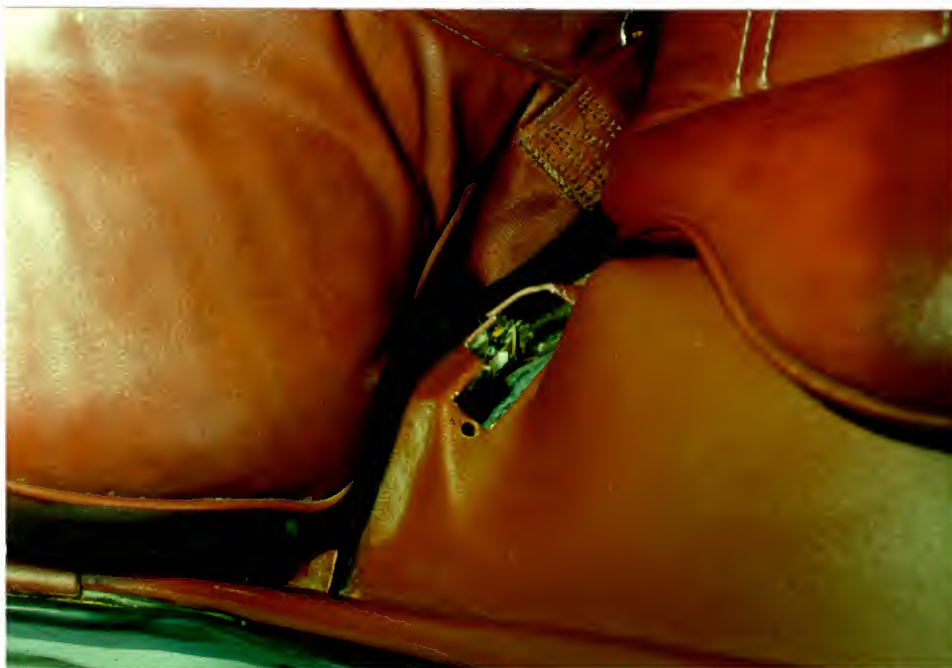
It was remotely possible that her head impacted the upper right quadrant of the left front seat back, thus hyperflexing, resulting in the spinal cord injury. Faint transfers (tissue) were noted to the possible area of contact. The front seat assembly was displaced forward; therefore, the left rear occupant would had to have been seated on the forward edge of the rear seat cushion to impact the seat back.

Possible Left Rear Occupant's Head Contact To The Front Seatback.

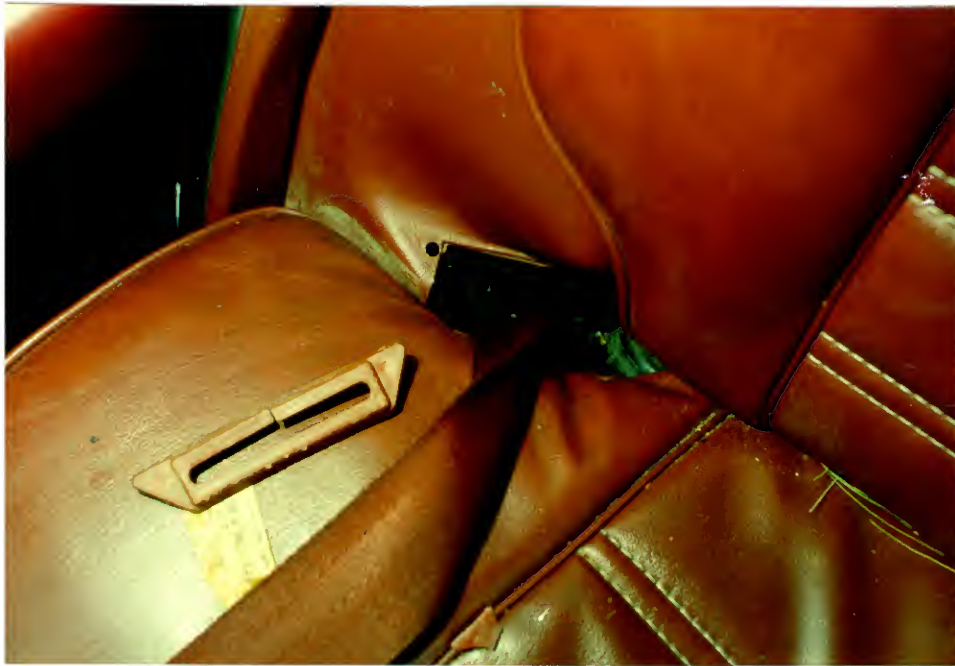
The left rear occupant was in an unknown seated position at impact. She was either holding a pet rabbit in a cardboard cage on her lap or had the cage positioned between her feet on the floor. The 6 year old occupant was wearing the lap belt that was equipped with an outboard mounted locking retractor. At impact, the passenger was thrust forward with respect to the decelerated vehicle and loaded the lap belt with her pelvic/abdominal area. Her unrestrained upper torso pitched forward which resulted in hyperextension of her head and transection of the cervical spinal cord.

Left Rear Occupant's Loading Damage To The Lap Belt Guide.

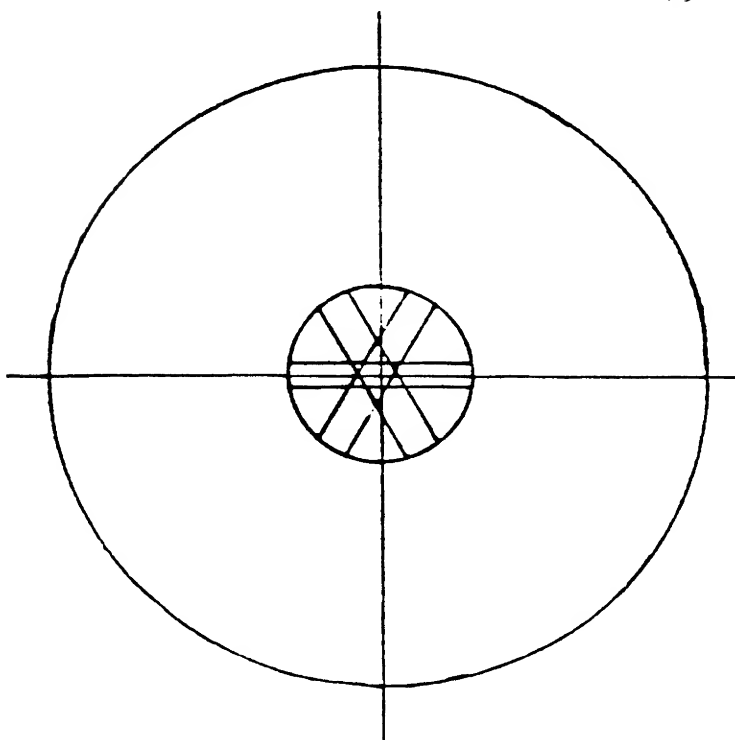
NO CONTACT EVIDENCE
ON AIR BAG
